THE SAN FERNANDO EARTHQUAKE AND PUBLIC SCHOOL SAFETY

BY D. E. HUDSON AND D. K. JEPHCOTT

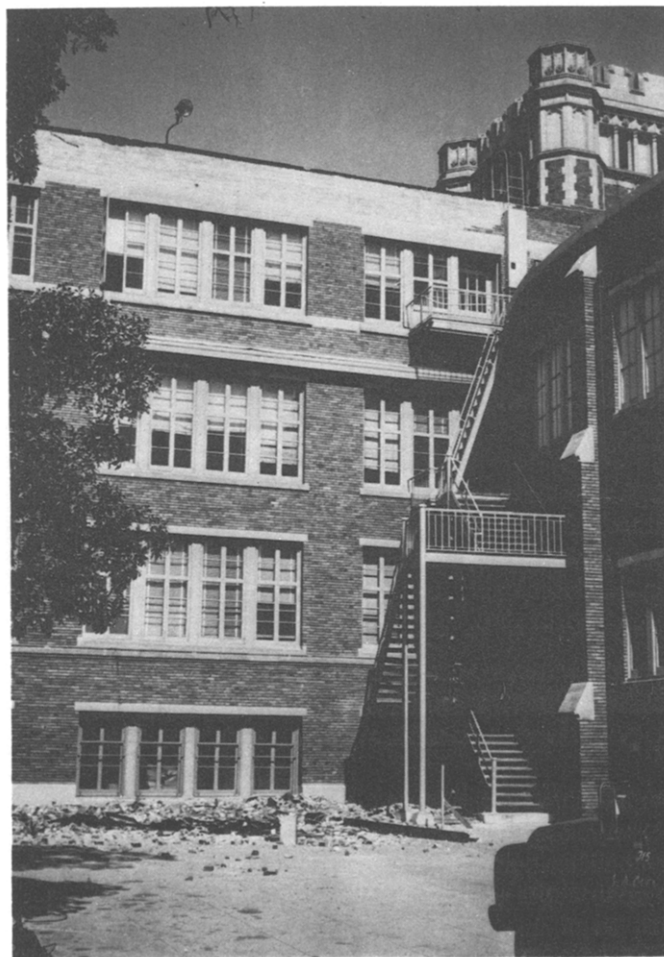
FIG. 6. Masonry wall damage at Los Angeles High School.

structures, severe structural damage to a pre-Field Act school will be cited. Figure 6 shows a view of a portion of the Los Angeles High School main building which was constructed in 1917, well before the day of earthquake codes and inspections. The school is some 25 miles south of the epicenter, and it can be judged from ground accelerations measured approximately one-half mile away that the ground acceleration was of the order of 0.10 g. It will be seen that substantial portions of the terra cotta and masonry parapets fell from the wall. Part of the debris buried a stairway which might have been serving as an emergency exit, and another portion fell through the roof of a lower wing into a classroom below, as shown in Figure 7. This is clearly a very hazardous situation which could have seriously injured students, had school been in session at the time of the earthquake. In this case, it was not economically feasible to repair and strengthen the building to current code requirements, and it was accordingly demolished. This is a

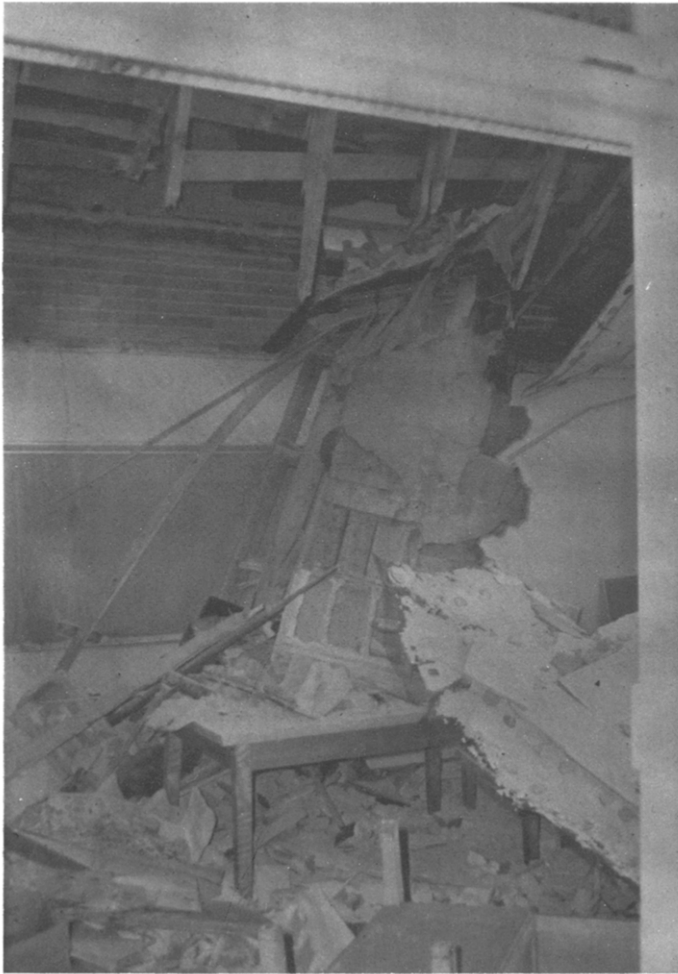
FIG. 7. Interior damage, Los Angeles High School.

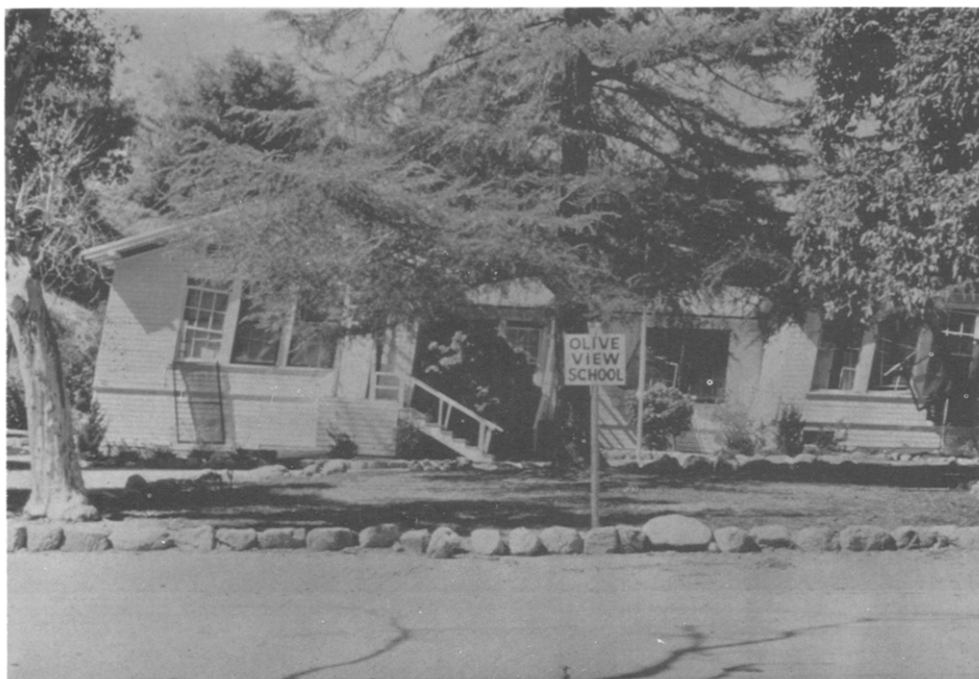
FIG. 8. Olive View Hospital School after earthquake.

The fate of a small school building on the Olive View Hospital site is of interest because of the widespread attention received by the collapse of two new hospital buildings there. Figure 8 shows the postearthquake appearance of the wood-frame school building, which was only several hundred feet from the collapsed hospital building. The building is typical of about 500 such school structures in use in the Los Angeles area at the time of the earthquake. Although the building was a total loss and was subsequently demolished, it is important to note that no hazardous collapse was involved and there would probably have been no serious injury to occupants.

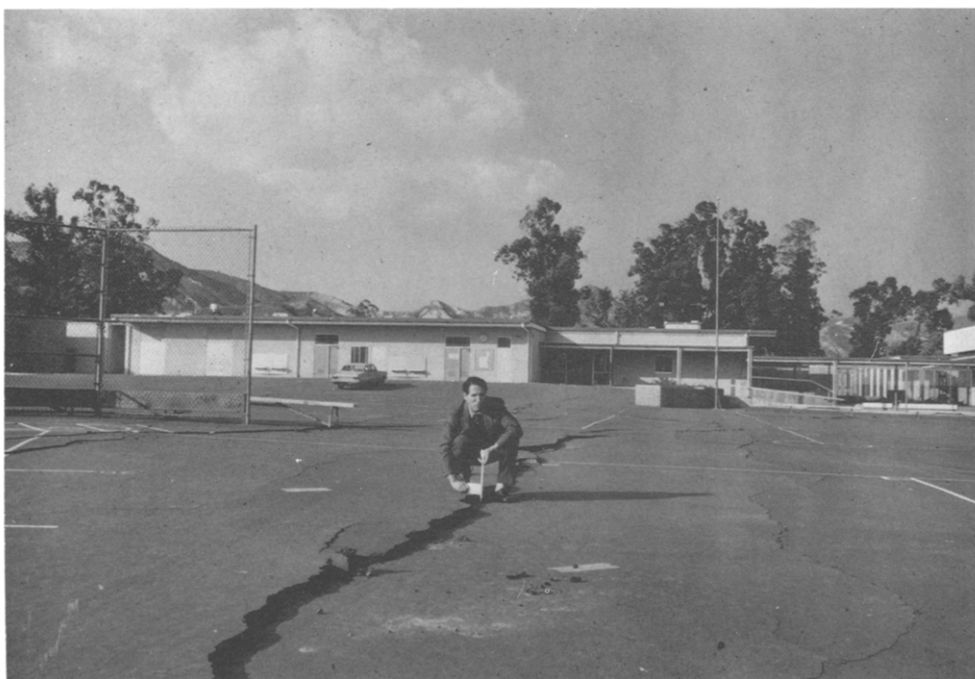
FIG. 9. Van Gogh Elementary School, showing cracks in playground.

were able to survive with no hazardous structural damage. Figure 9 is a view of the Van Gogh Elementary School, about one-half mile from the Upper Van Norman Lake Reservoir in an area which had peak horizontal ground accelerations of the order of $0.40 g$. There were numerous severely damaged structures in the immediate vicinity of the school. Although there was structural damage to the foundation footings, no hazardous structural damage occurred to the building. Figure 10 shows a substantial vertical ground displacement running through the grounds of the school at Camp Karl

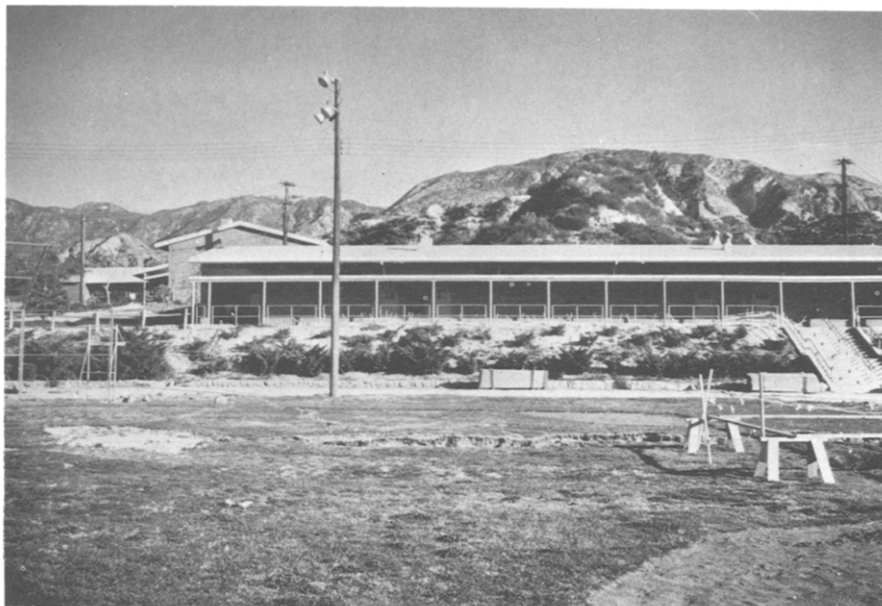
FIG. 10. School at Camp Karl Holton, showing vertical crack in playground.

Holton, 3 miles from Pacoima Dam and $1\frac{1}{2}$ miles from the main surface expression of the Tujunga Fault. Again an absence of hazardous structural damage to the school buildings is noted.

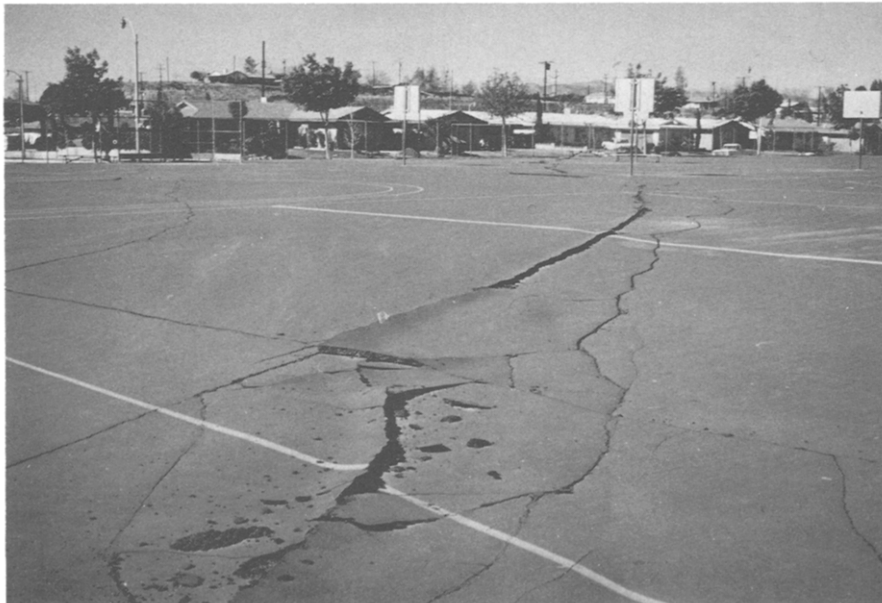
FIG. 11. Harding Street School, located in area of heavy ground disturbance (see Figure 4).

Another school in the immediate area of heavy ground disturbance is shown in Figure 11, and Figure 12 shows the results inside a classroom. Although considerable repairs were required, no hazardous situation was involved. A final example of severe ground distortion is at the Sylmar High School in Figure 13, in which a considerable disruption of walkways, arcades, etc., occurred, again without hazardous structural damage. It is

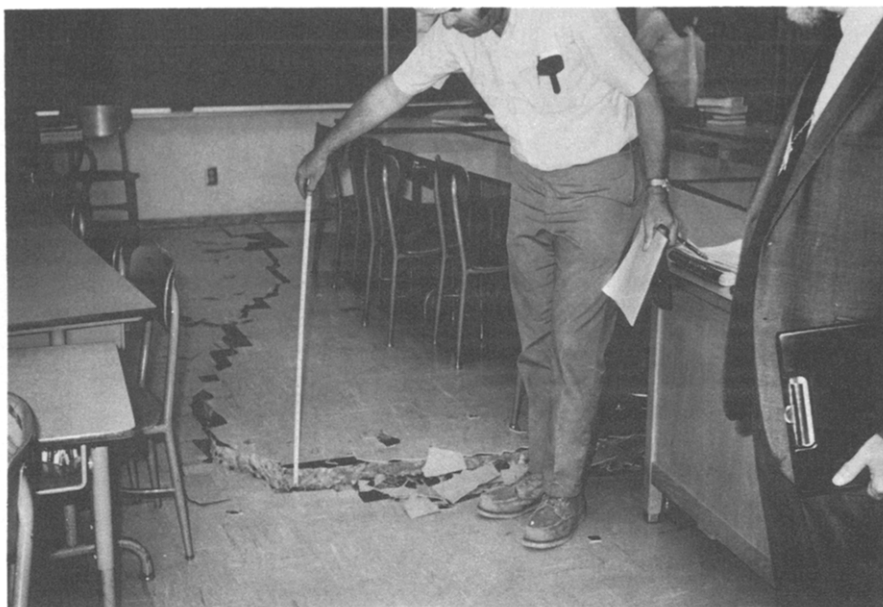
FIG. 12. Harding Street School, showing floor cracks inside classroom.

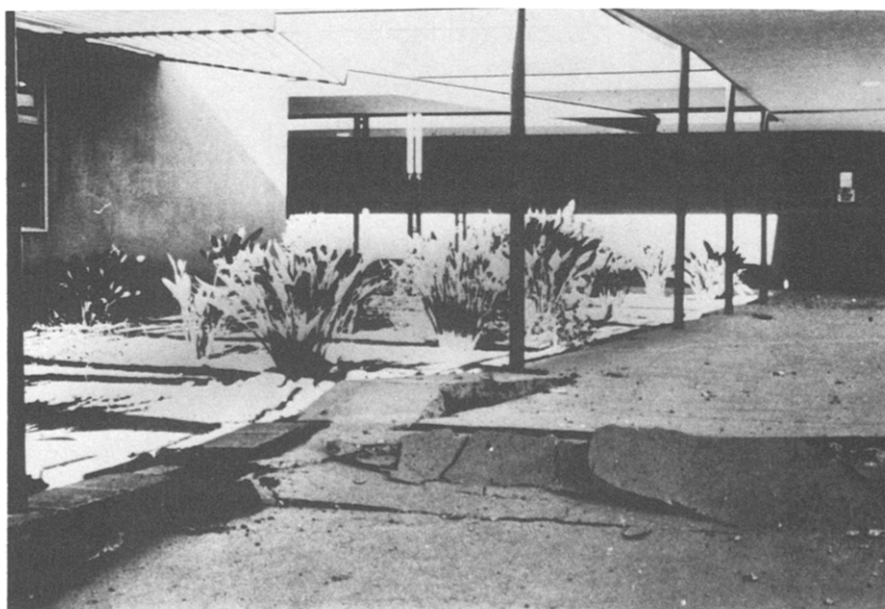
FIG. 13. Sylmar High School, arcade and walkway damage.

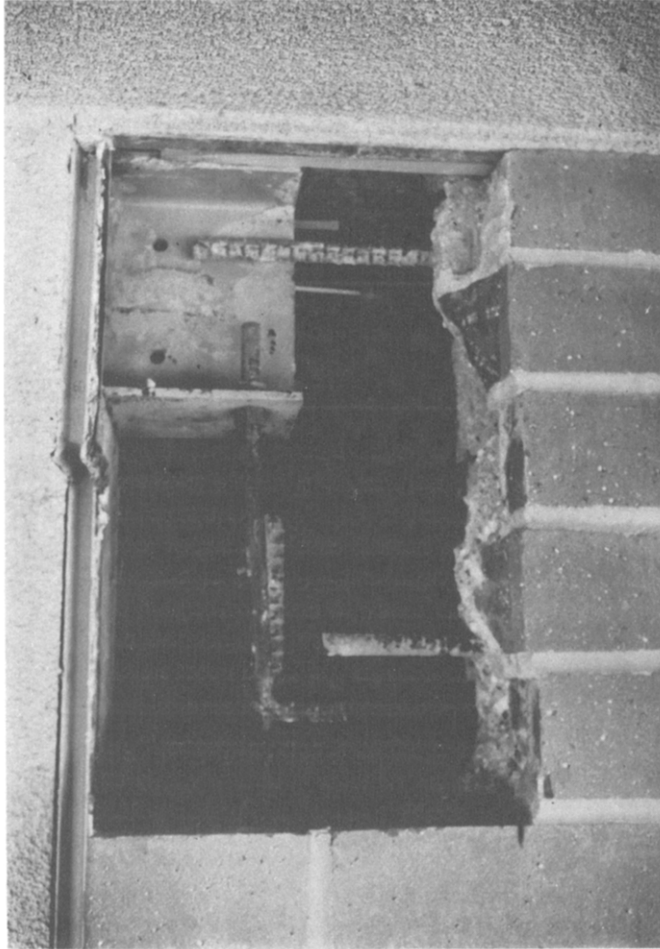
FIG. 14. Soledad Canyon Elementary School, unwelded reinforcing bar.

Interesting examples of minor damage directly attributable to construction and inspection defects occurred at the Soledad Canyon School. Figure 14 shows a reinforcing bar in a masonry wall which should have been welded to the steel I-beam. Such defects should be prevented by standard inspection techniques and simply point up the continuing necessity for vigilance in this respect.

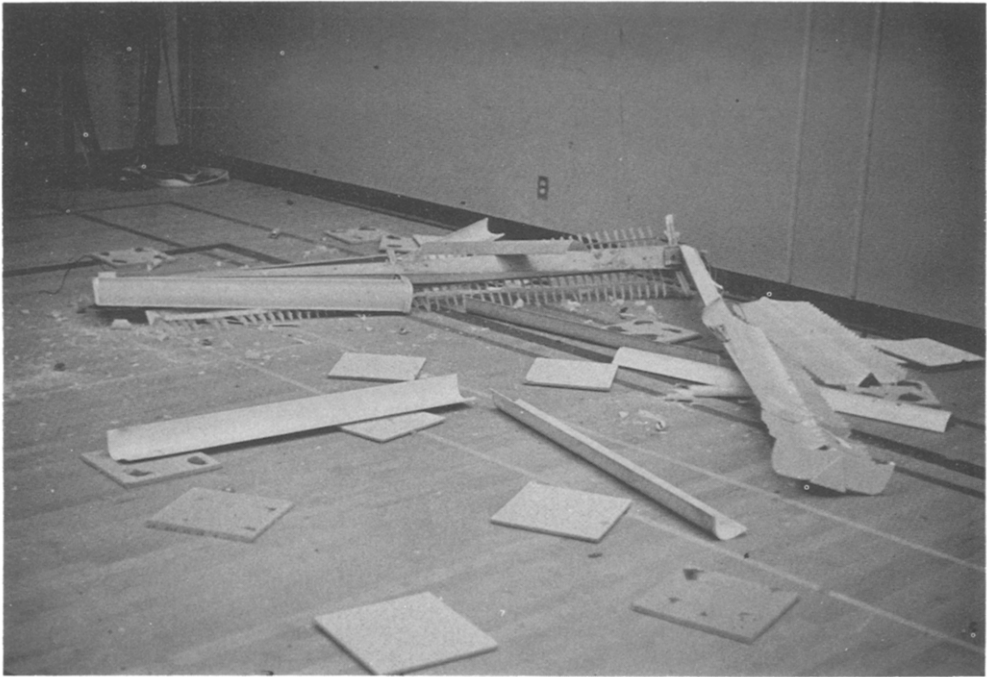
FIG. 15. Placerita Junior High School, failure of lighting fixtures.

The biggest hazards to life and limb in modern school structures were numerous failures of nonstructural elements. Typical examples are the overhead light fixtures of Figure 15, suspended T-ceilings of Figure 16, and unsecured equipment such as the lockers in Figure 17.

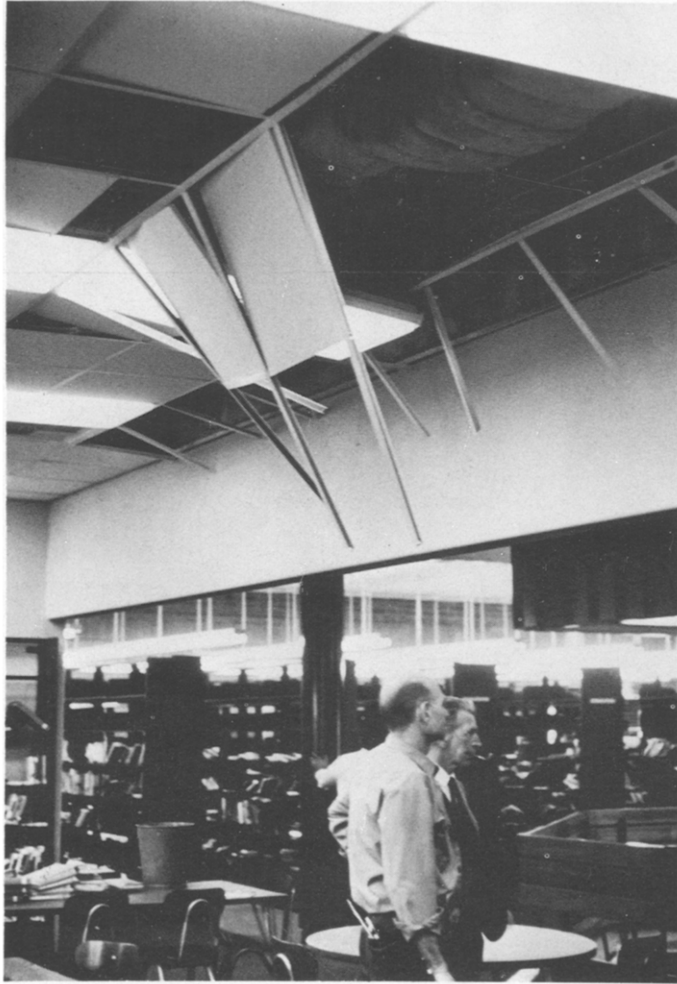
FIG. 16. Canyon High School, failure of suspended T-ceiling.

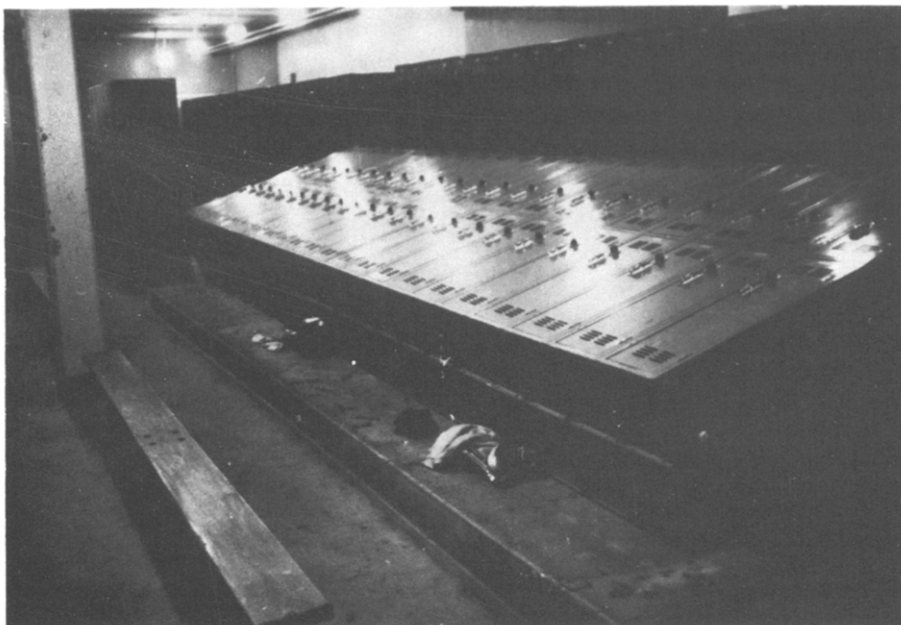
FIG. 17. Sylmar High School, toppling of lockers in gymnasium.

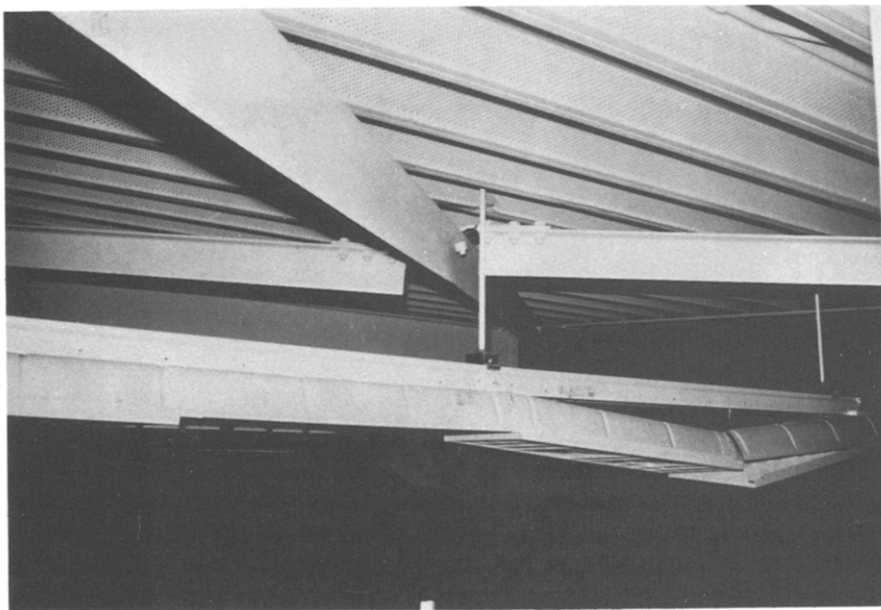
FIG. 18. Canyon High School, yielding of a steel roof member.

The absence of major structural damage in the modern school buildings throughout the epicentral region does not mean that very large structural forces were not involved or that excessive conservatism in the design had been used. Figure 18 shows a typical yielding response of a steel roof member showing that earthquake loads considerably in excess of ordinary design loads were encountered.
